# Zinc layer anode applied on reinforced concrete structures

**Abstract.** The application of zinc layer anode to reinforced concrete structure has been well known for many years. This galvanic cathodic protection system was specified being a corrosion control system for general steel in concrete as well as civil structures. A good way to determine the dimensioning elements of the galvanic protection system, is to carry out a pilot test being monitored in situ, and exposed under on site conditions including local concrete remediation or repair works. This paper presents an analysis of the current distribution and steel polarization data that have been collected from a car park project in the French Alps.

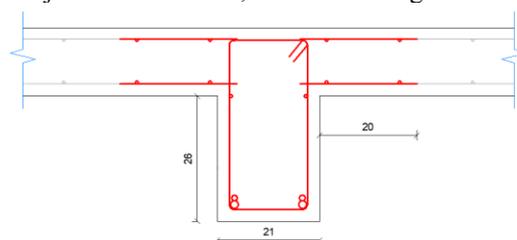
Fig. 2. Beam description

- Beam area: protection of all the rebars of the 6.5m beam and the first 20cm of reinforcement within the slabs adjacent to the beam, as shown in Figure 2.

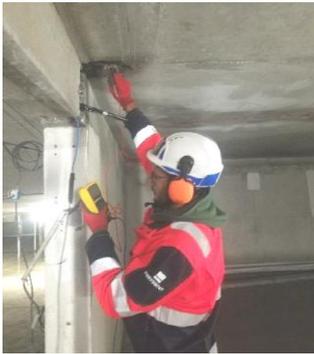
Fig. 4. Rebar electrical continuity test

The electric steel continuity shown in Figure 4 (longitudinal reinforcement, stirrup, top bars, bottom bars), was checked for a resistance of less than 1 ohm according to EN ISO 12696 [3]. In some cases, steel bars were welded to the existing reinforcement to restore electrical continuity.

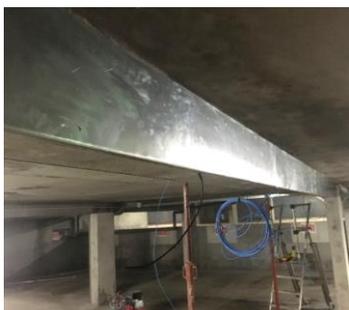
Fig. 5. ZLA on beam

On the beams, one strip of ZLA 450µm was applied on each vertical side as shown in Figure 5 and 7.

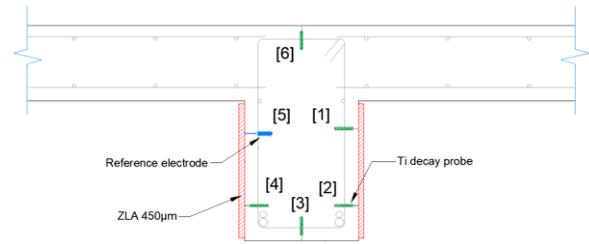
Fig. 7. Anode and monitoring description on beam

In each CP zone, 5 m<sup>2</sup> of concrete area, one ERE-20 electrode (Mn/MnO<sub>2</sub>) and five Titanium/MMO (Mixed-Metal-Oxide) potential decay probes were embedded in the concrete to monitor the throwing power and performance of the CP system at different locations.

Each electrode was placed in a borehole at a distance of 1 to 4cm from a steel bar. Each electrode was connected to copper cable type XLPE/XLPE 2.5mm<sup>2</sup> blue color for reference electrodes and yellow for potential decay probes.

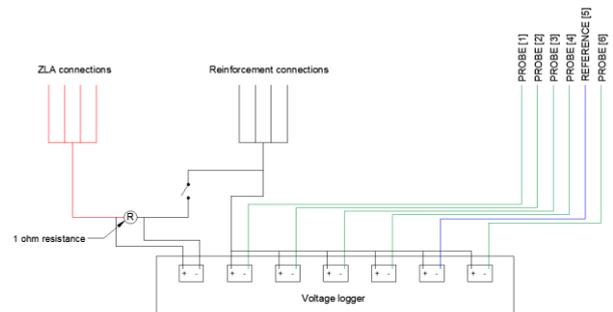
Fig. 9. Electrical scheme

All pilot test components were connected to copper XLPE/XLPE 2.5mm<sup>2</sup> cables, which are also connected to a voltage logger in the monitoring cabinet, shown in Figure 9.

Each test area was equipped with a data logger operating during the whole test period. The cables: anodic, cathodic and reference electrodes and potential decay probes, were all connected to this box. Each box was equipped with:

- Individual zinc strip to steel connections.
- Programmable data logger capturing and logging potentials and currents
- Temperature recorder.

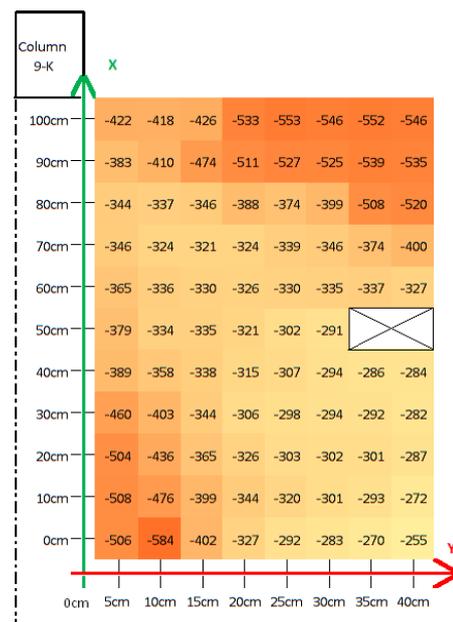
**Table 2.** Polarization effect (ON)

Table 2 shows the mapped potentials of the CP-system being on after 21 days polarization and Table 3 shows the off potential values of the soffit surface area after 24 hours depolarization.

The potential mapping carried out confirms that the arrangement of the ZLA strips on the beam did not affect or protect the steel of the soffit surface.

Reinforcement in this zone would therefore be considered to be out of the influence of the cathodic protection system and therefore were not protected against corrosion.

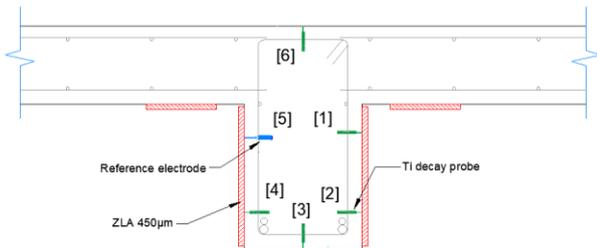
Fig. 11. ZLA layer on slab soffit

In order to obtain polarization effects for the slab soffit close to the beam, just a half layer (12,5 cm) of ZLA 450  $\mu\text{m}$  was applied on the slab soffit as shown in Figure 11.

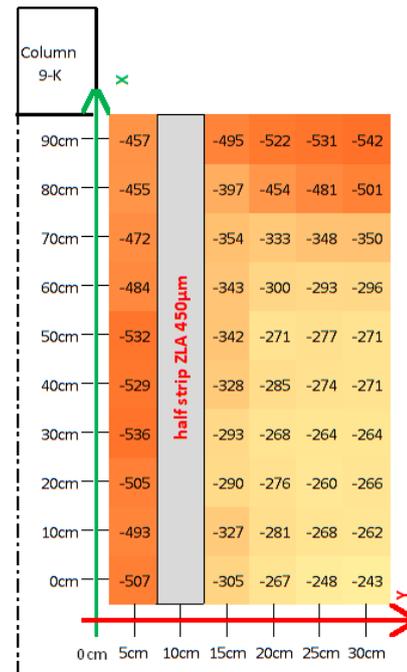
Table 5. Potential before installation

According to previous measurement on permanent reference electrode installed into the beam, surface potential measurements were carried out. Table 5 and 6 show the results of the On potentials mapped before and after the new configuration being installed

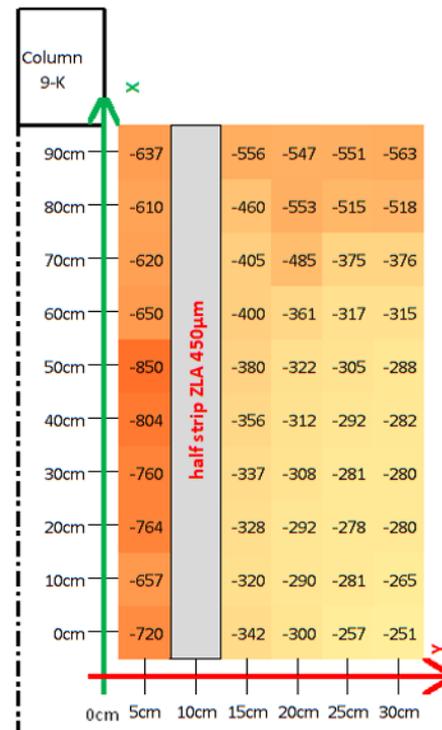
Table 6. Potential after installation

The potentials mapped confirm the positive effect of the additional ZLA strip being installed on the soffit, potentials adjacent to the new anode shifted more than 40 mV.

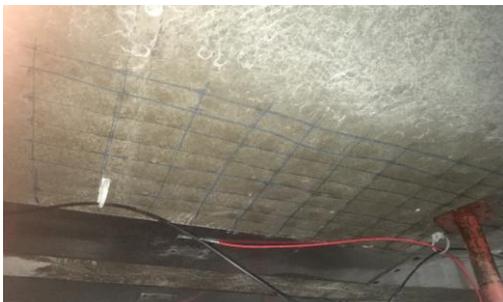
**Fig. 12.** Potential mapping area

The potential mapping details of the cracked area shown in Figure 12 are:

- Support: slab soffit adjacent to the ZLA
- Scope of mapping: 1.00m x 0.40m
- Grid of the mapping according to the direction of the ZLA: Axis-Y: 5 cm, Axis-X: 10 cm, 86 measures
- Electrode used: Cu/CuSO<sub>4</sub>

The potentials mapped confirm the throwing power of the ZLA up to a distance of 20cm.

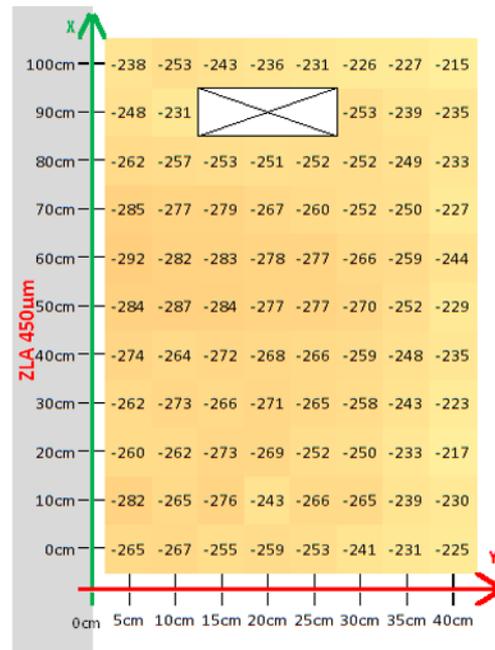
**Table 8.** Potential mapping before connection

Tables 8 and 9 show the mapped potentials of the neighboring zones to the zinc strip.

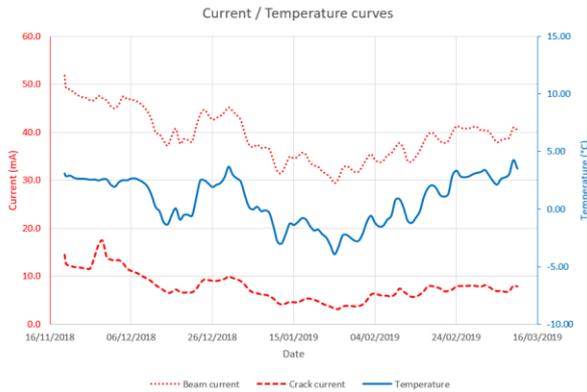
**Fig. 13.** Anodic current (mA) versus temperature (°C)

Considering the current outputs and temperatures over four months' time during winter time, we clearly see a temperature dependence of the current output as shown in Figure 13, we can expect that during summer

time this temperature effect on anodic current should be in the same range or greater.
